**PHASE IB ARCHEOLOGICAL RECONNAISSANCE SURVEY FOR
MILTON STP SDWK(8) (HOBBS ROAD) AND ARCHEOLOGICAL
RESOURCE ASSESSMENT (MCMULLEN ROAD)**

Hobbs Road and McMullen Road Sidewalks

Town of Milton
Chittenden County, Vermont

July 2011

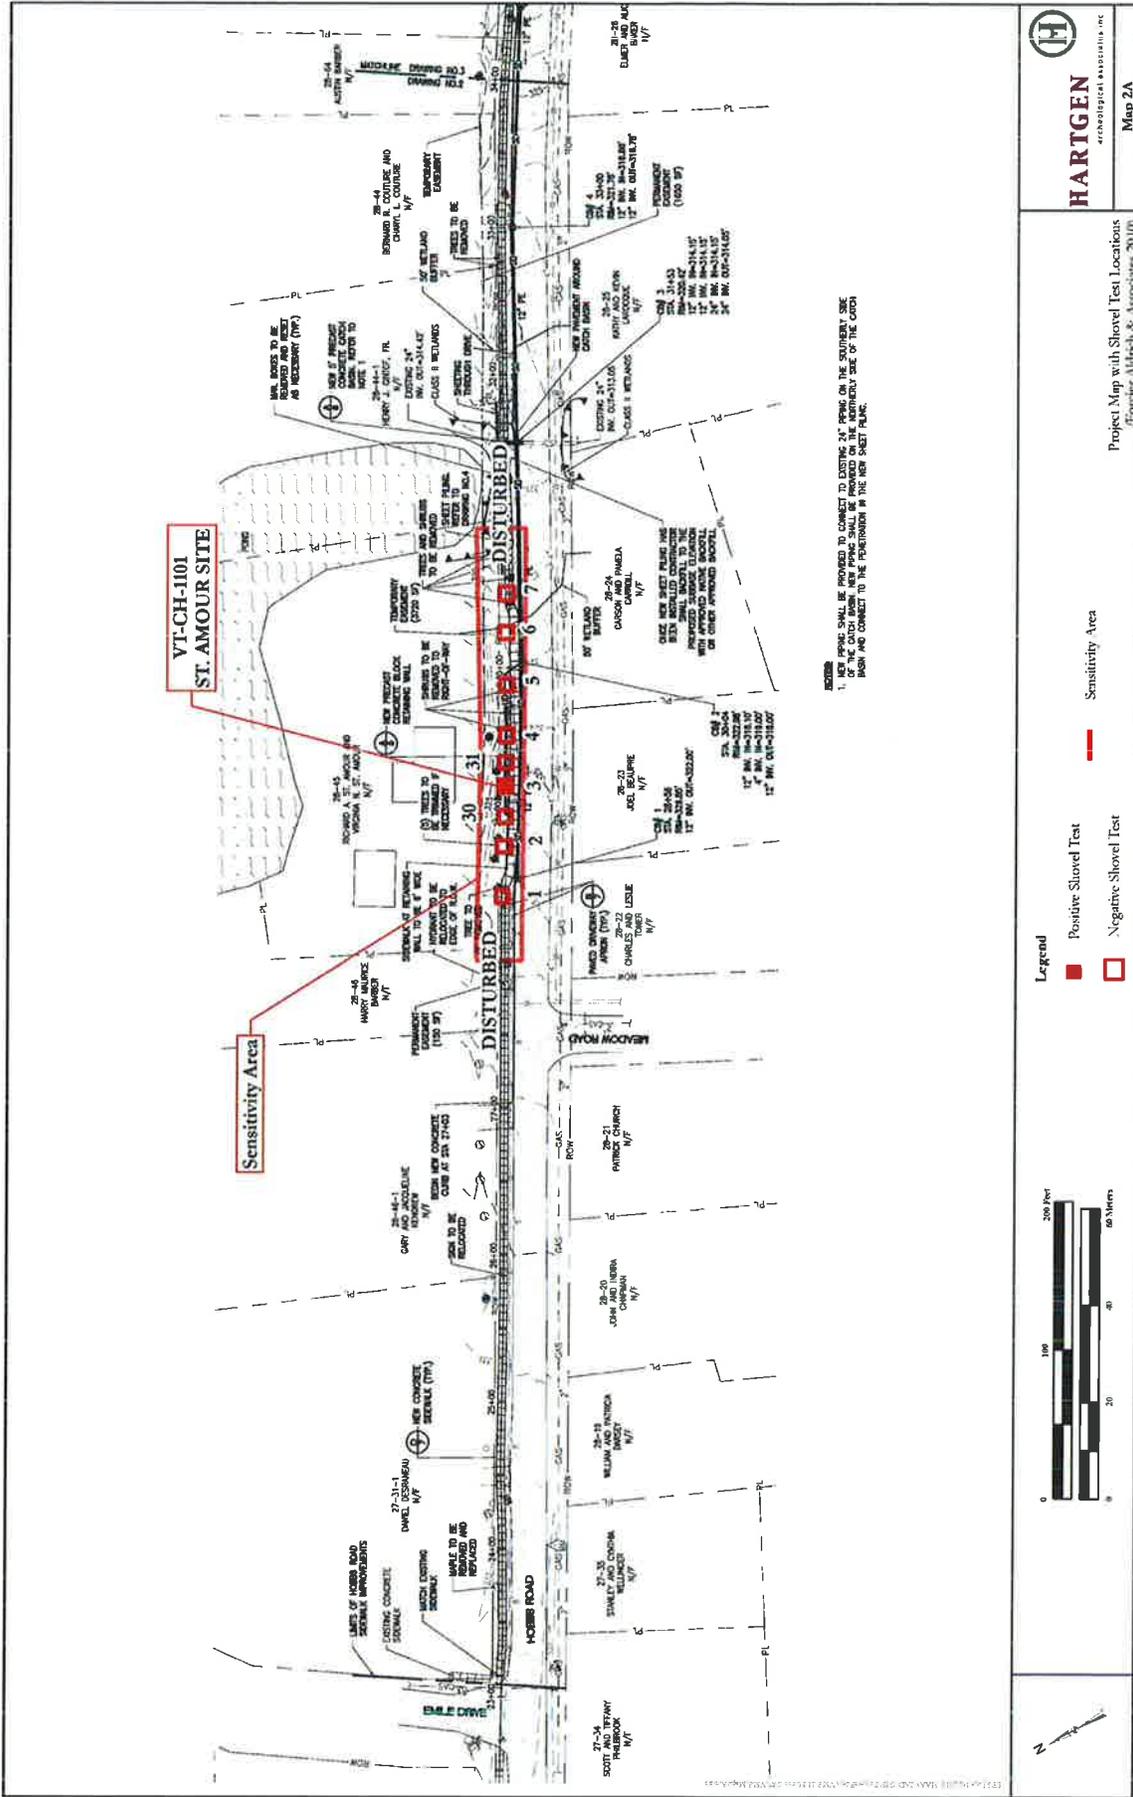
Project Map with Shovel Test Locations
 (Forester, Albrecht & Associates 2010)

- Positive Shovel Test
- Negative Shovel Test
- Sensitivity Area

Phase IB archeological reconnaissance survey was conducted along the project alignment on Hobbs Road on May 31 and June 1, 2011 (Maps 2A and 2B). The two areas of testing within the APE, Sta. 29+00 to 31+00 and Sta. 36+00 to 44+00, were identified by VTrans as archeologically sensitive.

Tests 8 through 29 were excavated east of the brook (Map 2B) with only small areas skipped over due to the presence of driveways and disturbance. The stratigraphy of these tests was more complex than the tests located west of the brook, due to disturbance and filling along the side of the road. Eight of the 22 tests had intact stratigraphy. The remaining tests exhibited stratigraphy that included various amounts of fill such as sand, gravel and cobbles. The high frequency of fill along this portion of the APE is probably related to the area being at or (in the case of parts of the eastern end) below the road surface when the gravel road was maintained by spreading gravel regularly. The fill ranged from approximately 10 to 50 cm (4 to 20 in) in depth throughout this alignment. With the exception of the Wells Site discussed below, there was a low frequency of late 19th- and 20th-century artifacts encountered in these tests.

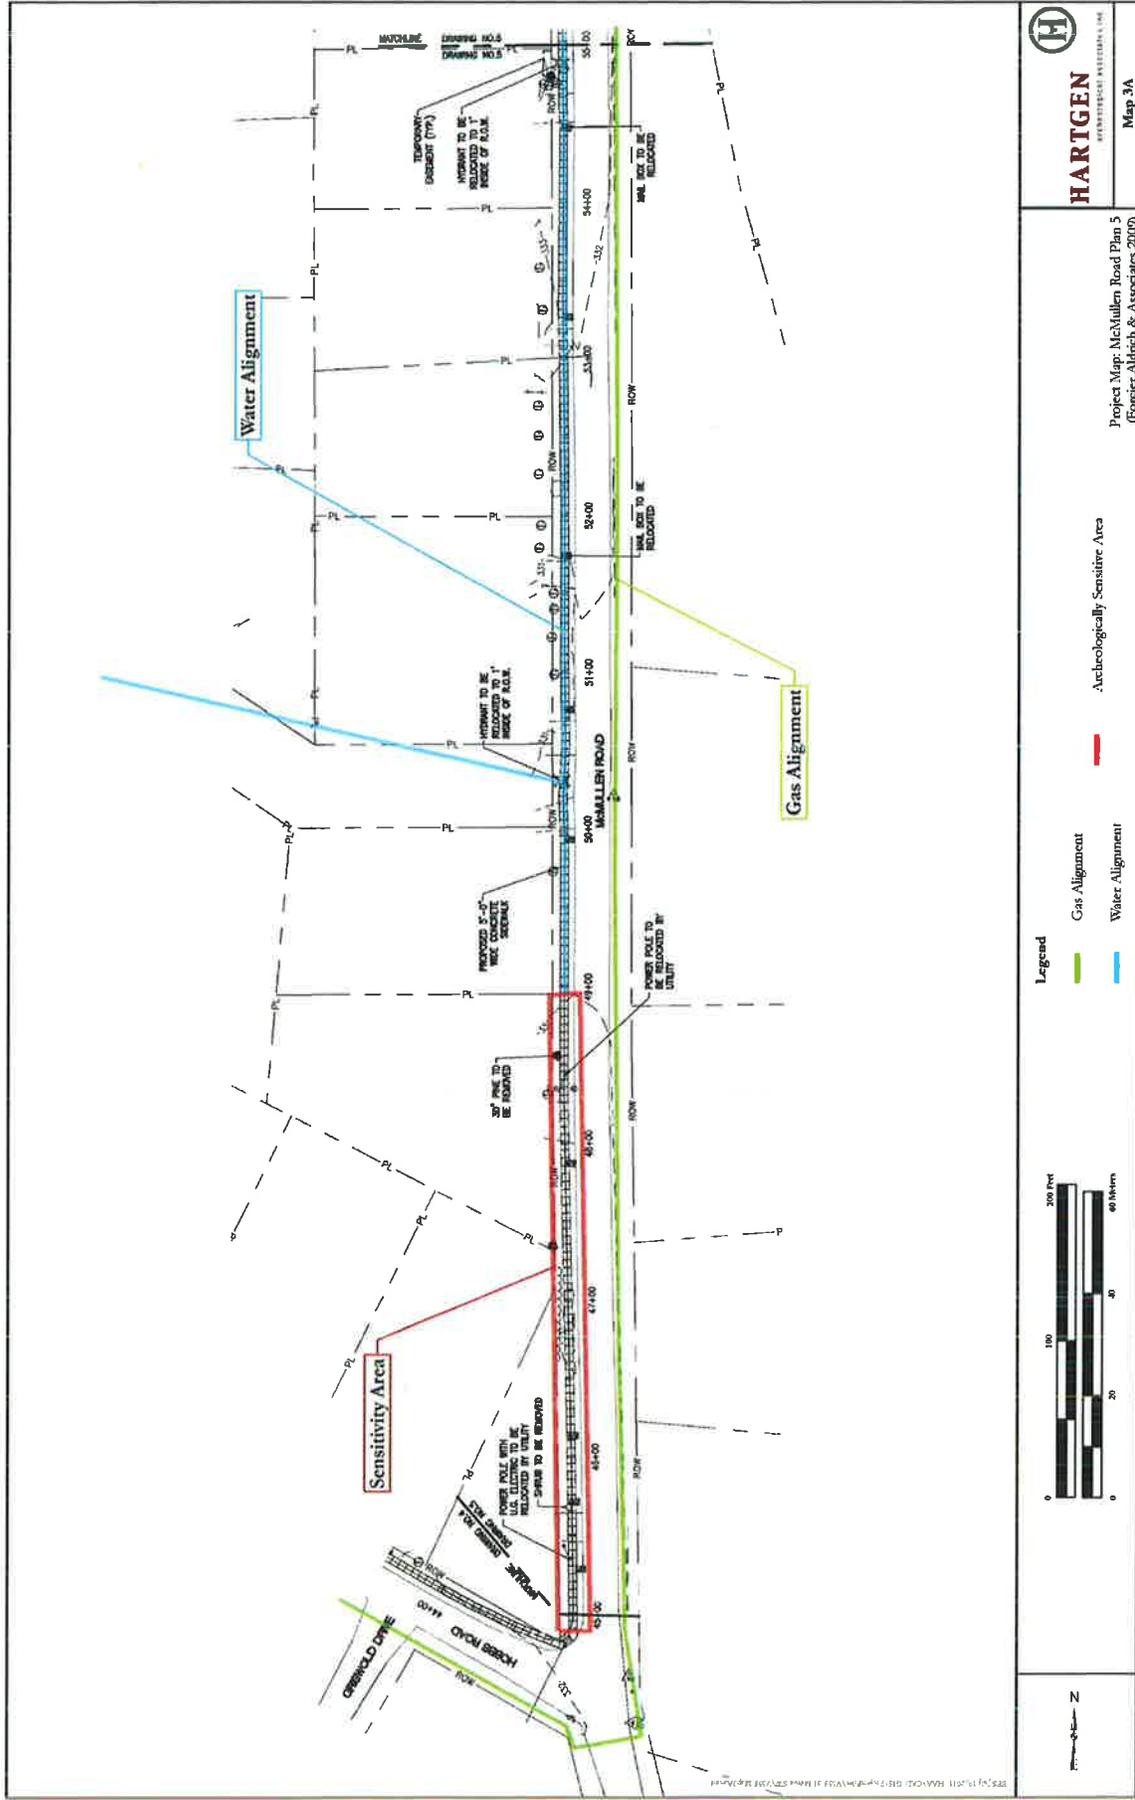
HARTGEN
 ENGINEERING PROFESSIONAL S.E.
 Project: Map McMullen Road Plan 5
 (Foster, Adrich & Associates 2007)
 Map 3A

- Gas Alignment
- Water Alignment
- Archeologically Sensitive Area

The McMullen Road APE has been heavily disturbed by utility installations. A small section at the southern end of the APE between Sta. 45+00 and 49+00 appears to be undisturbed and is considered archeologically sensitive for precontact deposits.

Most of the McMullen Road APE has been disturbed by installation of water and gas utility lines adjacent to the road. A small section of the southern end of the APE has not been disturbed and is considered sensitive for precontact archeological deposits.

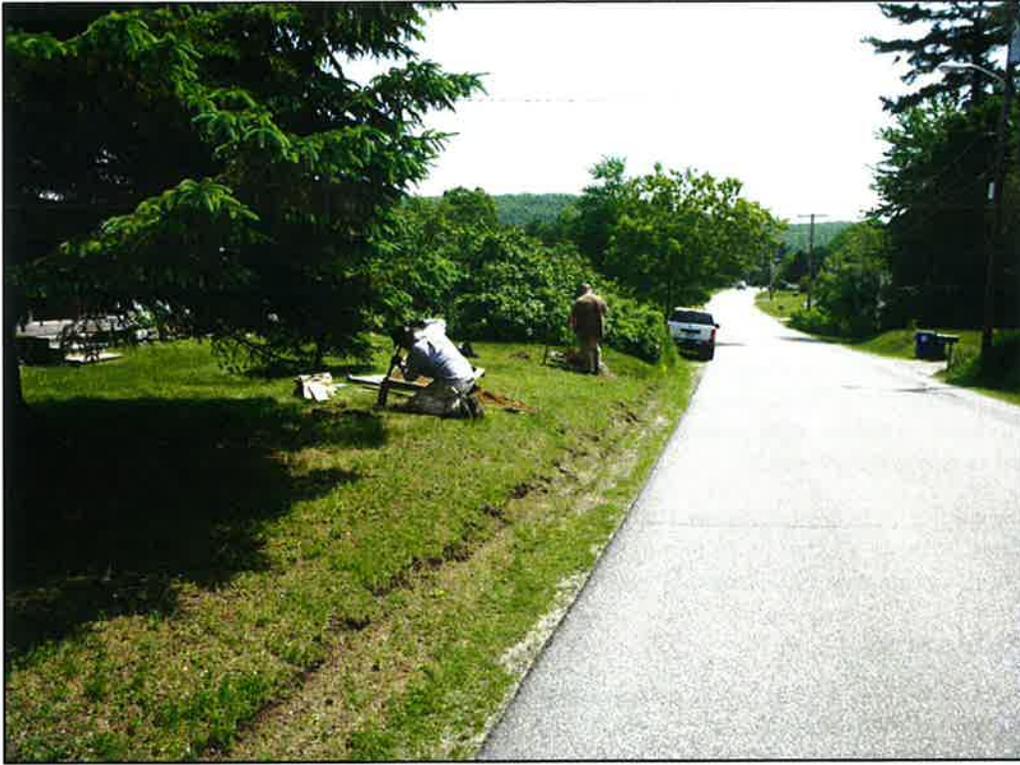
Photo 1. Hobbs Road, shovel testing west of the brook. Note level terrace in the foreground and lower terrace beyond. Tests 3 and 4 being excavated. View to the east/southeast.

The sensitivity area west of the brook encompasses a raised terrace on the west end and a lower terrace directly adjacent to the brook (Photo 3). The intact soil stratigraphy of the area tested west of the brook consisted of 20 to 30 cm (8 to 12 in) of very dark brown sandy loam A horizon, over 20 cm (8 in) of dark yellowish brown sand B horizon, with an olive brown sand C horizon below. However, Tests 3, 4 and 6 encountered different degrees and types of disturbance.

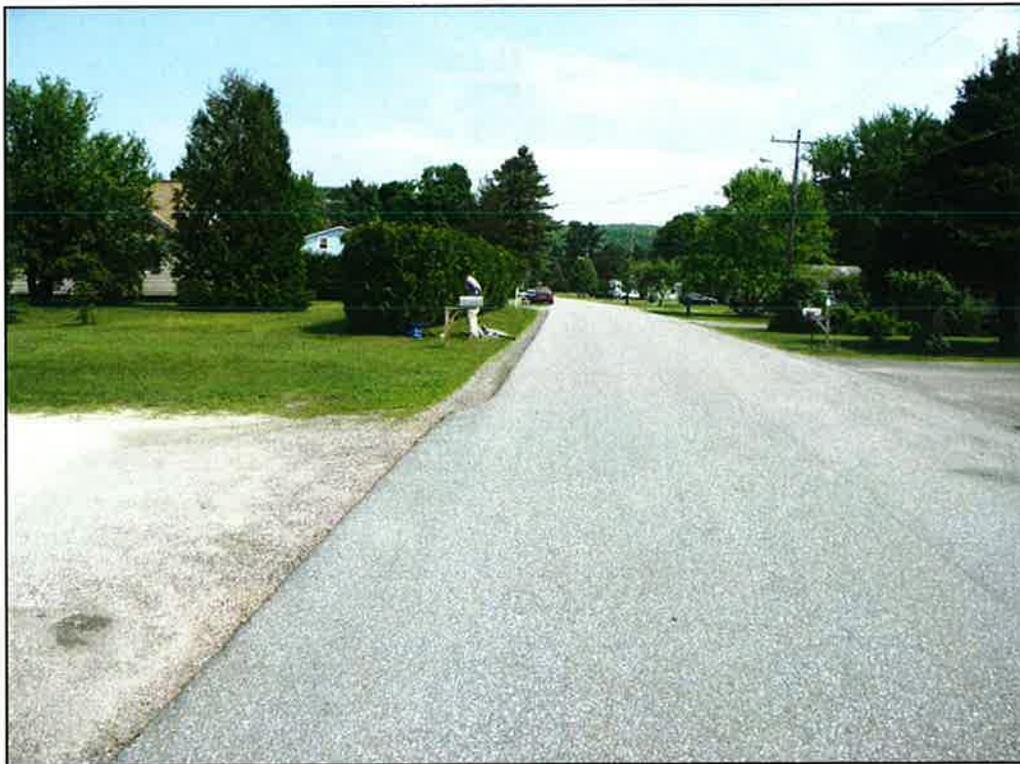
Photo 2. Hobbs Road, shovel testing east of the brook. Note level terrain and residential neighborhood. View to the east/southeast.

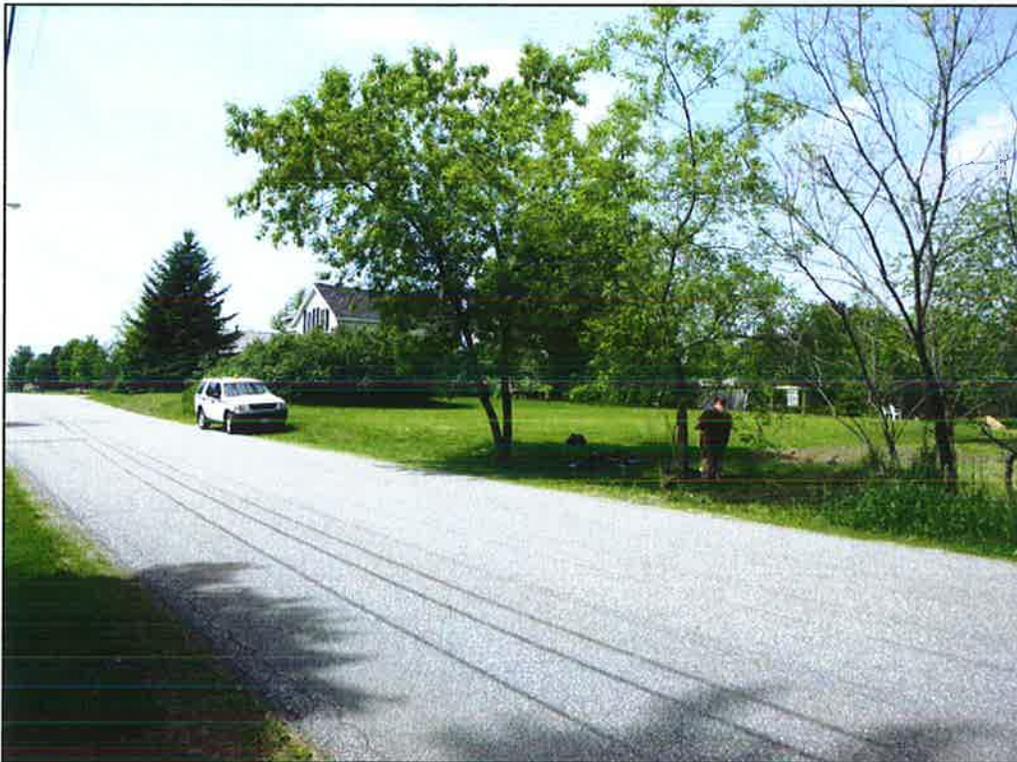
Photo 3. Hobbs Road, shovel testing west of the brook. Note lower terrace in the foreground adjacent to the brook and the St. Amour house and upper terrace in the background. View to the west/northwest.

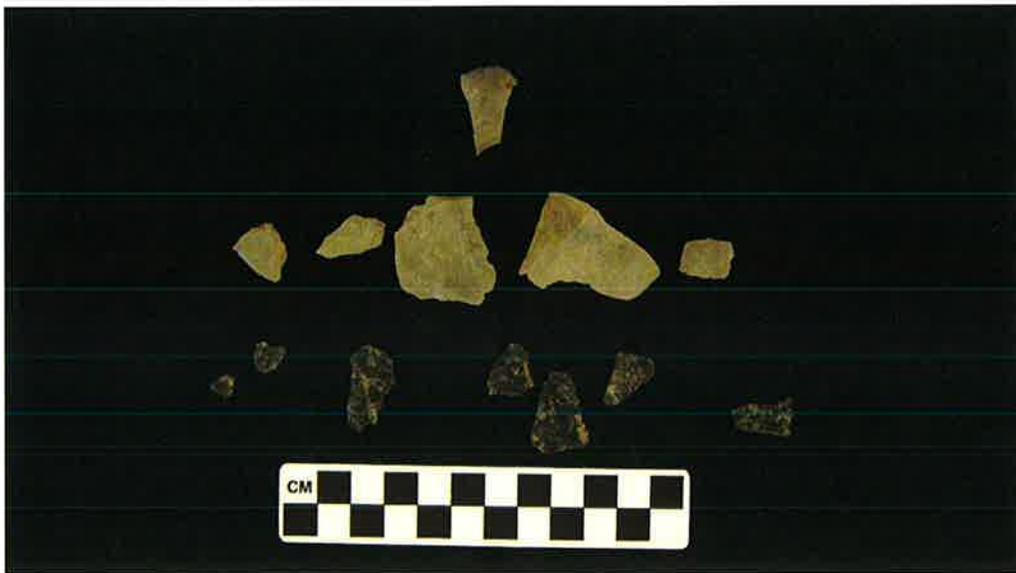
Photo 4. Hobbs Road, St. Amour Site (VT-CH-1101): top row: utilized flake 1763.2.1 (Hathaway chert); middle row five thinning flakes 1763.2.2 (Hathaway chert); bottom row: two trim flakes 1763.2.7, thinning flake 1763.3.1, three thinning flakes 1763.3.2, thinning flake 1763.2.5 (all bottom row Clarendon Springs chert).

The flakes found in Test 3 were of two different chert types, Hathaway and Clarendon Springs (Photo 4). They were found in Levels 3, 4 and 5. Twenty of the flakes were of Clarendon Springs chert and 118 were of Hathaway. The flakes were primarily thinning flakes and trim flakes, associated with reshaping and sharpening stone tools such as projectile points, spear points and knives. The larger amount of Hathaway material may account for the presence of some shatter, a block flake and a utilized flake in the collection.

The two chert material types encountered in Test 3, Hathaway and Clarendon Springs, are found in relatively close proximity to the project area, along the shore of Lake Champlain. Hathaway chert is known to have been quarried in the St. Albans vicinity and Clarendon Springs chert outcrops in the Charlotte and Colchester vicinities (Burke 1997). Many sites in the area have lithics derived from these two sources. It is likely that the occupants of the project area migrated through the region on a seasonal round that included visits to lithic sources to obtain raw materials for stone tool production.

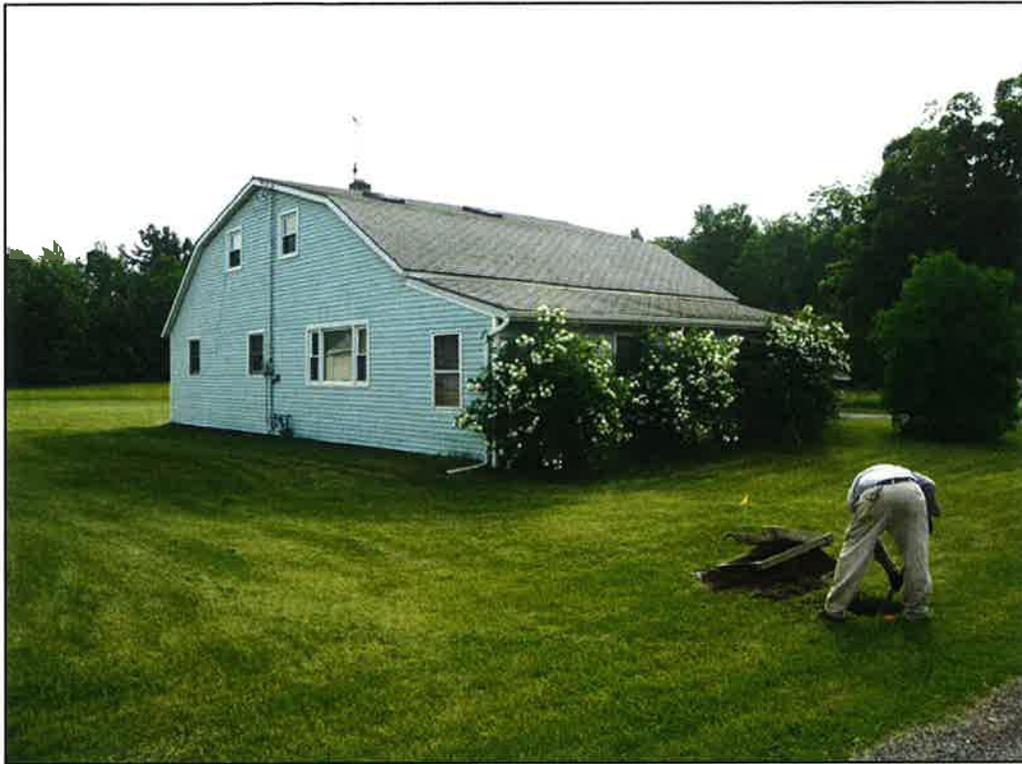
Photo 5. House at #60 Hobbs Road, possible 19th-century house associated with the Wells Site (VT-CH-1102) encountered in four shovel tests along the adjacent roadside. View to the east.

The high frequency of artifacts coinciding with the adjacent house suggests they are the edge of a sheet midden dating to the 19th-century occupation of the house. The site has been assigned the Vermont Archeological Inventory number VT-CH-1102 (the Wells Site).

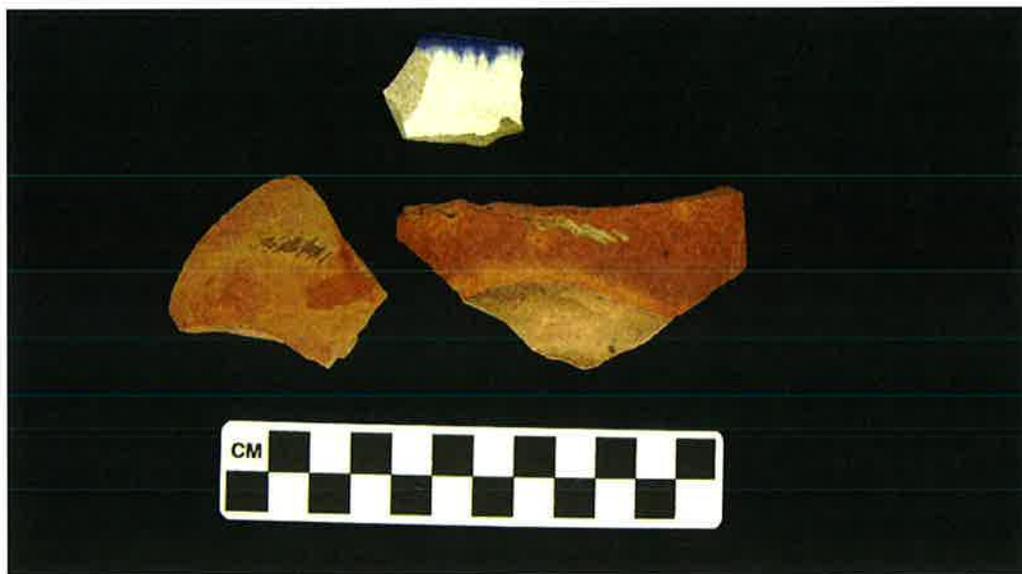
Photo 6. Hobbs Road, Wells Site (VT-CH-1102): top row: blue edged whiteware plate fragment [1763.14.3]; bottom row: lead glazed redware 1763.14.2 and lead glazed slip decorated redware 1763.14.1.

The artifacts are dominated by domestic ceramics with a few glass and architectural materials. The ceramics include fragments of lead and copper glazed redware, blue edged whiteware, flow blue transfer print whiteware, sponge decorated whiteware and polychrome hand painted whiteware (Photos 6 and 7). The architectural materials include cut and wire nails, brick and window glass.

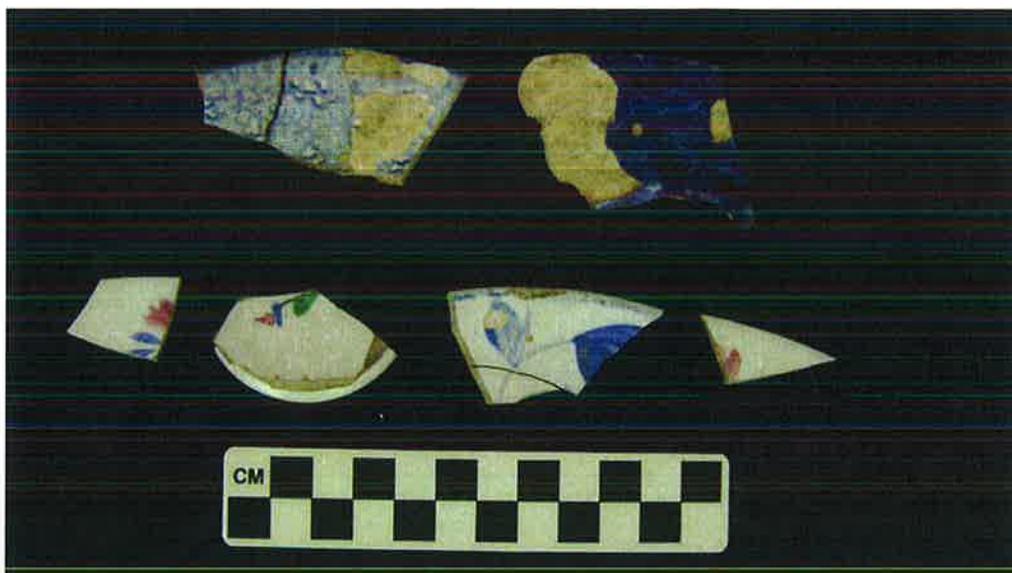
Photo 7. Hobbs Road, Wells Site (VT-CH-1102): top row: blue transfer print whiteware plate fragment, 1763.17.5, flow blue transfer print whiteware plate fragment 1763.17.4; bottom row: hand painted polychrome whiteware 1763.17.8, hand painted polychrome whiteware footring and base fragment 1763.17.11, blue hand painted whiteware 1763.17.7 and red hand painted whiteware 1763.17.9.
